VISUALIZATION AND INTERPRETATION OF IMPACT ECHO DATA FROM BRIDGE DECK TESTING

Paper submitted for presentation in TRB 87th annual meeting and publication in Journal of Transportation Research Board, Transportation Research Record.

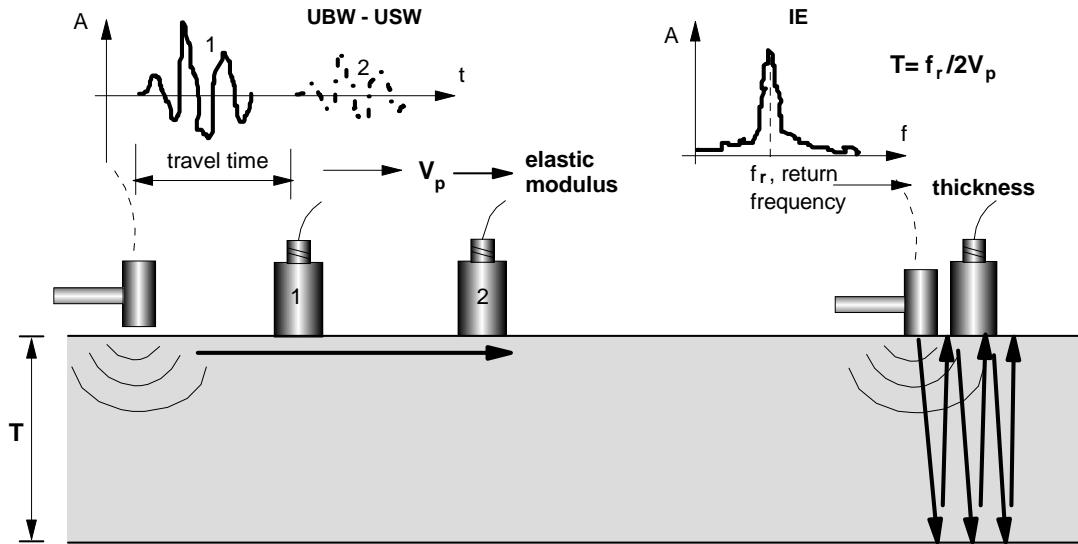
Application of UBW, USW and IE techniques in the evaluation of a bridge deck is illustrated in Figure 1. In the first part of the evaluation, the UBW and USW tests are conducted using an impact source and two receivers. The UBW technique is used to measure the velocity of propagation of compression (P) waves. By measuring the travel time of the P-wave between two receivers, the first wave arrivals, the P-wave velocity (V_p) is calculated. Because it is often difficult to identify P-wave arrivals in an automated way, a more reliable procedure to estimate the P-wave velocity is through a measurement of the surface (Rayleigh or R) wave velocity using the USW test. The USW test is identical to the SASW test (7,8), except that the frequency range of interest is limited to a narrow high frequency range where the velocity of the surface wave (phase velocity) does not vary significantly with frequency (9). Variation in the phase velocity would be an indication of variation of material properties (elastic moduli) with depth. Once the R-wave velocity is determined, it can be well correlated to both compression and shear (S) wave velocities, and thus to the Young's and shear moduli. In the second part of the evaluation, the IE test is conducted using an impact source and a single nearby receiver. Because of a significant contrast in rigidity of concrete and air, the elastic wave is practically entirely reflected off the bottom of the deck back to the deck surface. The frequency of the reflection, called return frequency, can be identified in the response spectrum of the recorded signal. Finally, the depth of the reflector, in this case the deck thickness, can be obtained from the return frequency and the previously determined P-wave velocity, as illustrated in Figure 1.

FIGURE 1 Measurement of bridge deck elastic modulus and thickness by UBW and IE methods.

While the primary objective of IE testing is to determine dominant reflectors, according to the relationship described in Figure 1, a unique thickness or depth of the reflector can be correlated to every component of the frequency spectrum. This is illustrated in Figure 2 by a frequency spectrum, and the corresponding thickness spectrum. The thickness spectrum enables simple data interpretation, because positions of the dominant and secondary peaks describe clearly the pattern of energy partitioning, and thus the degree of delamination. Spectra for a set of points along a single test line can be combined to form spectral surfaces. As shown in the same figure, frequency spectra for one test line on a bridge deck are combined to form a frequency spectral surface and are converted into a corresponding thickness spectral surface. The following observations, regarding the advantages of the two surface types, can be made when linear scales are used for both frequencies and depths. The frequency spectral surface

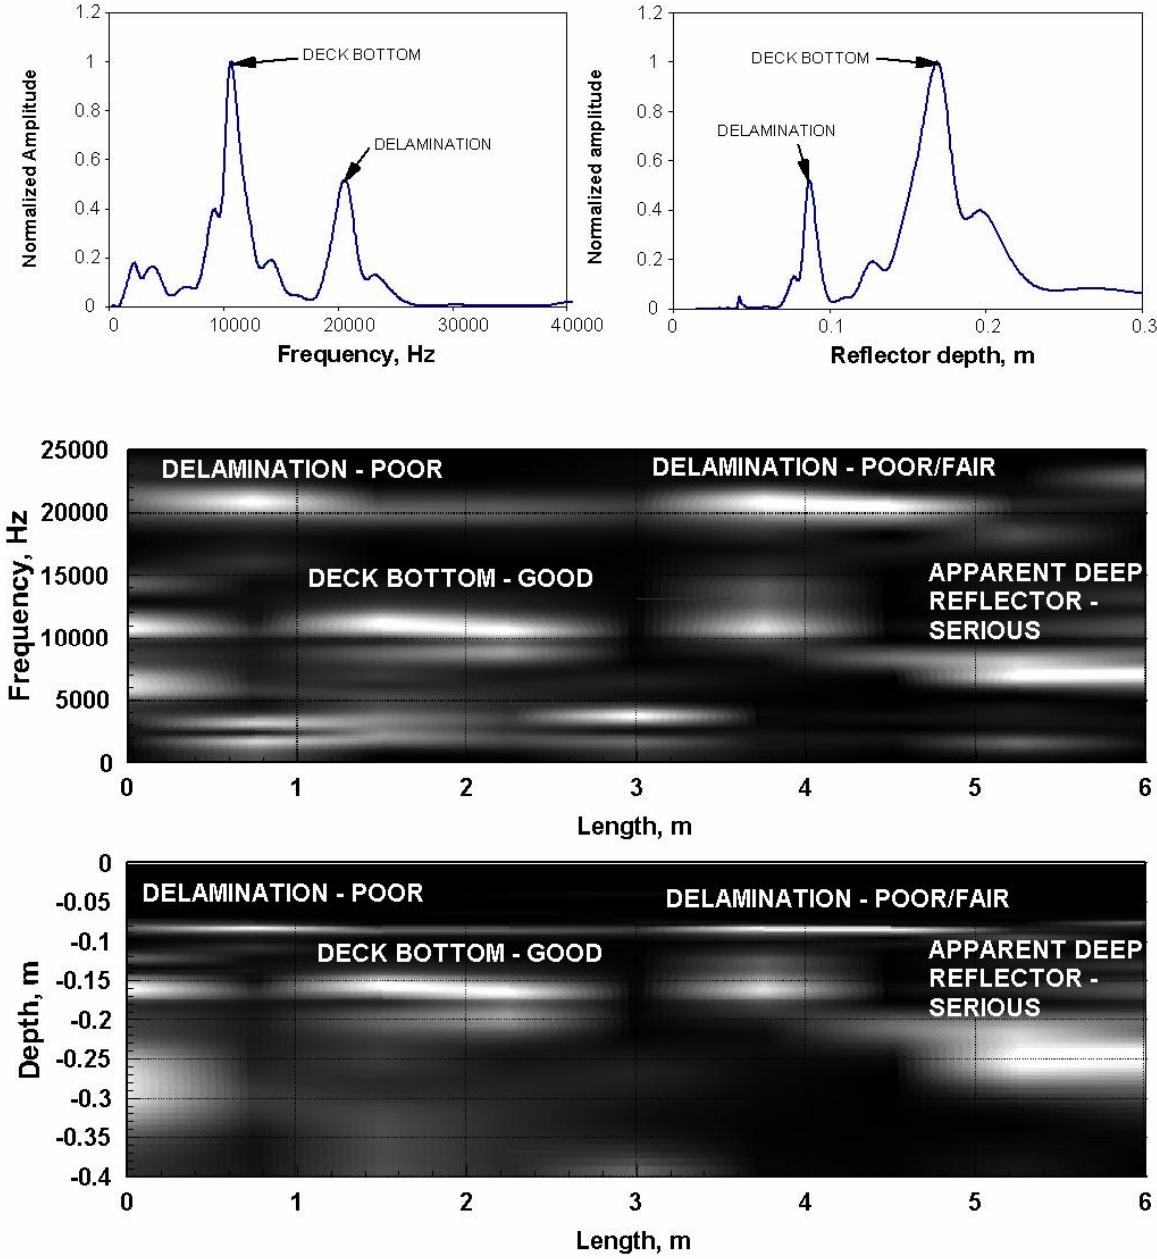
emphasizes presence of shallow delaminations, while the thickness spectrum emphasizes presence of apparent deep reflectors, deck zones in a serious condition that will be discussed in the following section (10). Because the thickness spectral surface represents a more natural choice for data viewing, a properly selected nonlinear depth scale can provide a well-balanced image for identification of all detected reflectors.

FIGURE 2 Frequency and thickness spectra and spectral surfaces.

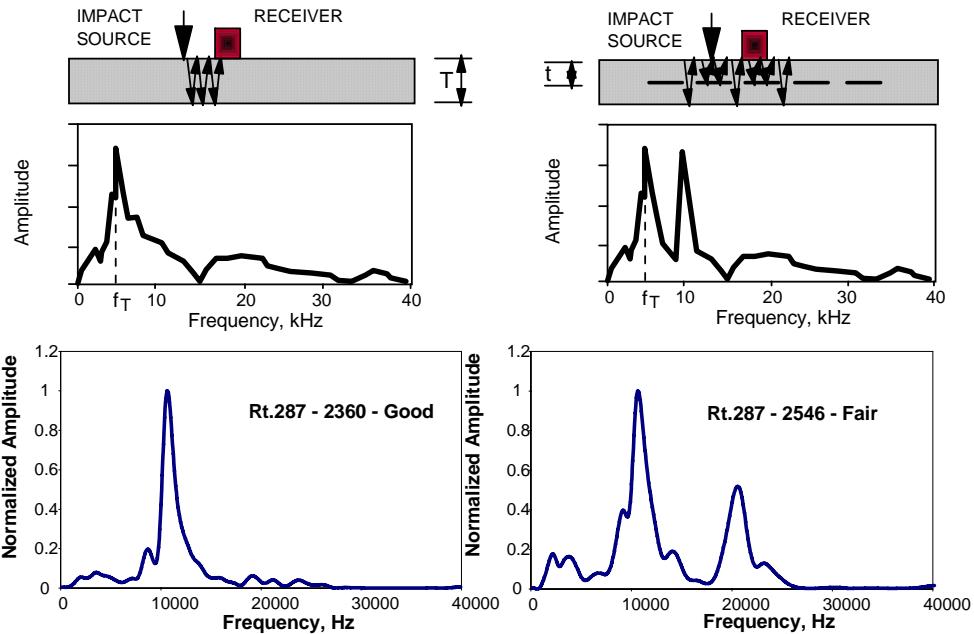
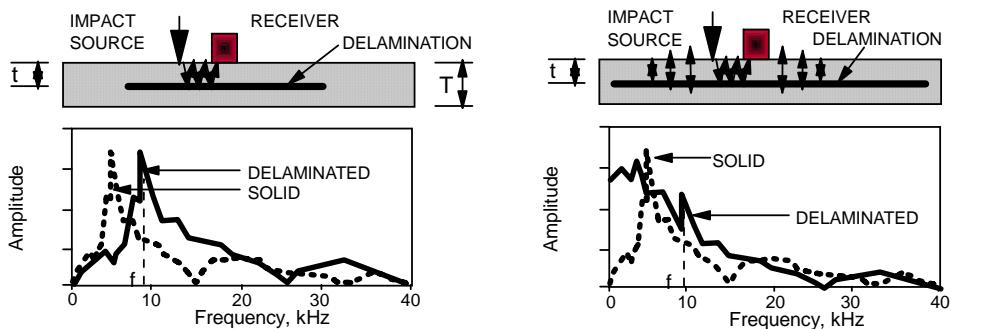
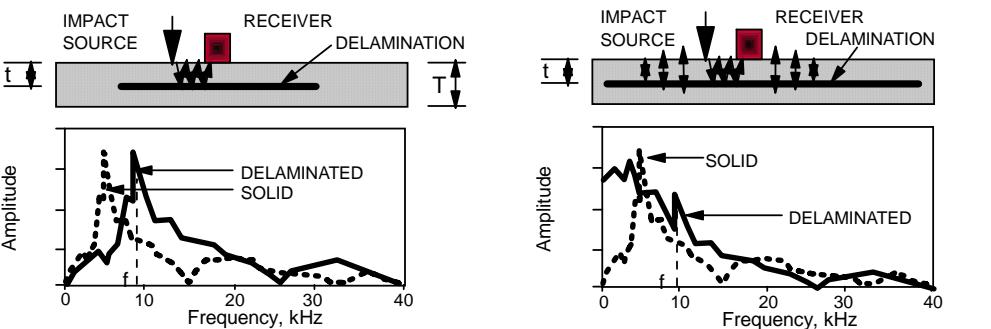
that particular section of a deck as a part of the condition assessment process. This is illustrated in Figure 3. In the case of a sound deck (good condition), a distinctive peak in the response spectrum corresponding

FIGURE 3 Grades for various degrees of deck delamination.

to the full depth of the deck, can be observed. This is illustrated by two spectra under the schematic of the bridge deck. The upper spectrum in the figure represents a schematic of the expected spectrum, while the lower spectrum is taken from actual field testing. Initial delamination (fair condition) is described as occasional separations between the two deck zones. It can be identified through the presence of two

distinct peaks, indicating energy partitioning from two dominant wave propagation patterns. The first peak corresponds to reflections from the bottom of the deck, while the second corresponds to reflections from the delamination. Progressed delamination (poor condition) is characterized by a single peak at a frequency corresponding to a reflector depth that is shallower than the deck thickness, indicating that little or no energy is being propagated towards the bottom of the deck. Finally, in a very severe case of a wide delamination (serious condition), the dominant response of the deck to an impact is characterized by a low frequency response of flexural mode oscillations of the upper delaminated portion of the deck. This response is almost always in the audible frequency range, unlike response of the deck in the fair and poor condition that may be in the ultrasonic range. Because it is significantly lower than the return frequency for the deck bottom, it produces an apparent reflector depth that is larger than the deck thickness.

In the case of a delaminated deck, reflections of the P-wave occur at shallower depths, causing a shift in the response spectrum towards higher frequencies. Depending on the extent and continuity of the delamination, the partitioning of energy of elastic waves may vary and different grades can be assigned to

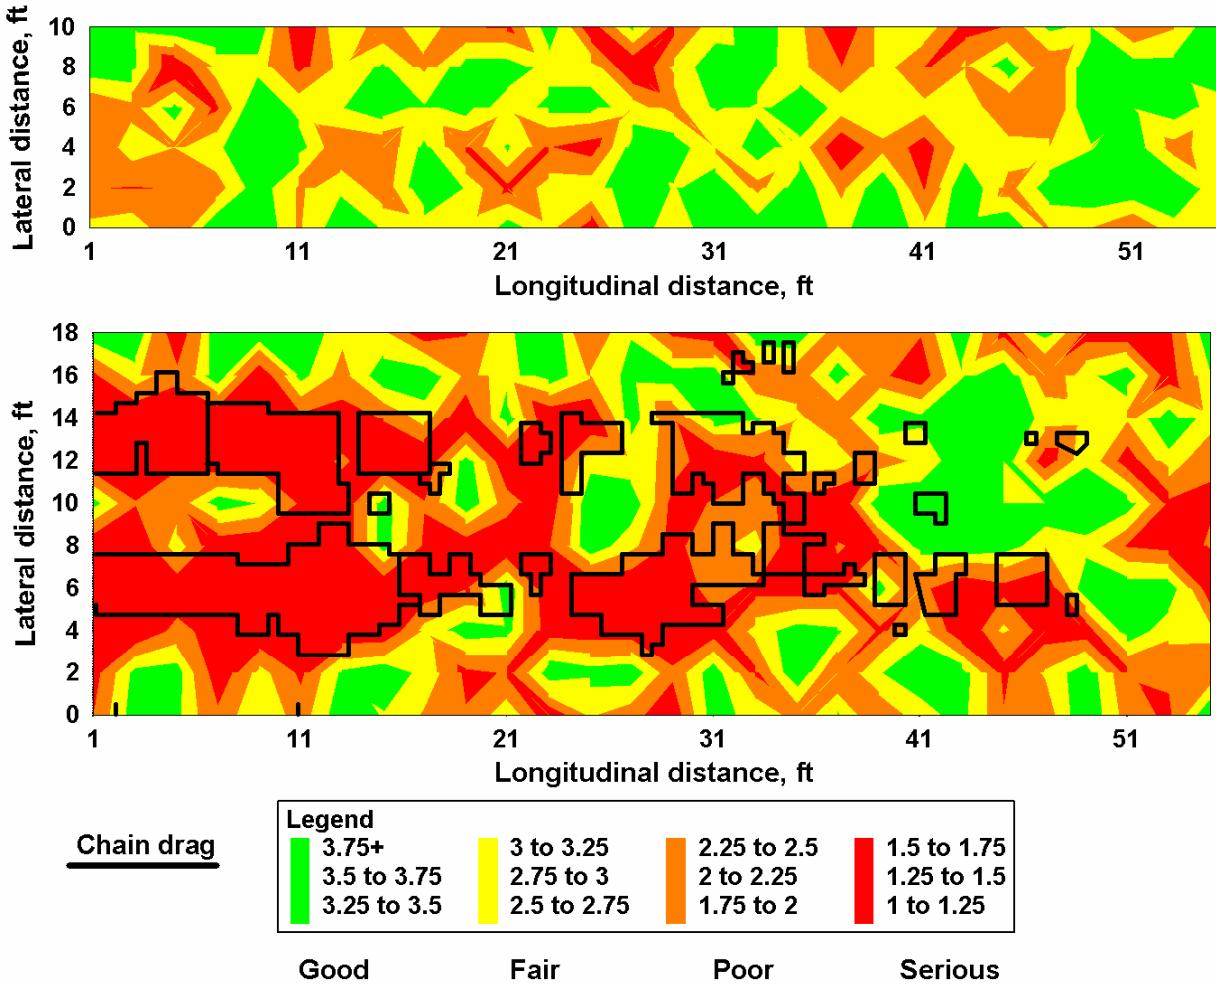
FIGURE 5 Condition assessment maps for Carter Creek Bridge (top) and Van Buren Bridge (bottom).

PSPA testing results are commonly described in terms of shear and Young's moduli (or P- and S-wave velocity) distributions, and condition assessment distributions (with respect to the degree of delamination). This is illustrated by conditions maps for sections of two bridges in Virginia, Carter Creek and Van Buren bridges (Figure 5). As can be observed in the upper condition assessment plot for the Carter Creek bridge, the deck is in a good condition and only smaller zones of initial and progressed delamination, and minor zones of a deck in a serious condition, can be identified. On the other hand, the bottom condition assessment plot for Van Buren bridge deck illustrates a deck in a significantly deteriorated condition. Zones of all previously described conditions (grades) can be identified in the condition assessment plot. Since the deck was also evaluated by chain dragging, the PSPA results were compared to those of the chain drag. The comparison points to similarity of the two approaches in detection of areas with progressed delamination (poor to serious condition). The ability of the chain drag to identify zones in a serious condition can be explained by the fact that the frequency response in such cases is in the audible range. On the other hand, the most of the zones identified by the PSPA as zones of initial delamination (fair to poor grades) were not detected by the chain drag. This ability to detect signs

of initial delamination represents a significant advantage of the PSPA device (seismic ultrasonic testing) over the chain drag approach. It allows more accurate definition of boundaries of delaminated zones, better prediction of delamination progression, and leads to better assessment and timing for implementation of rehabilitation measures.

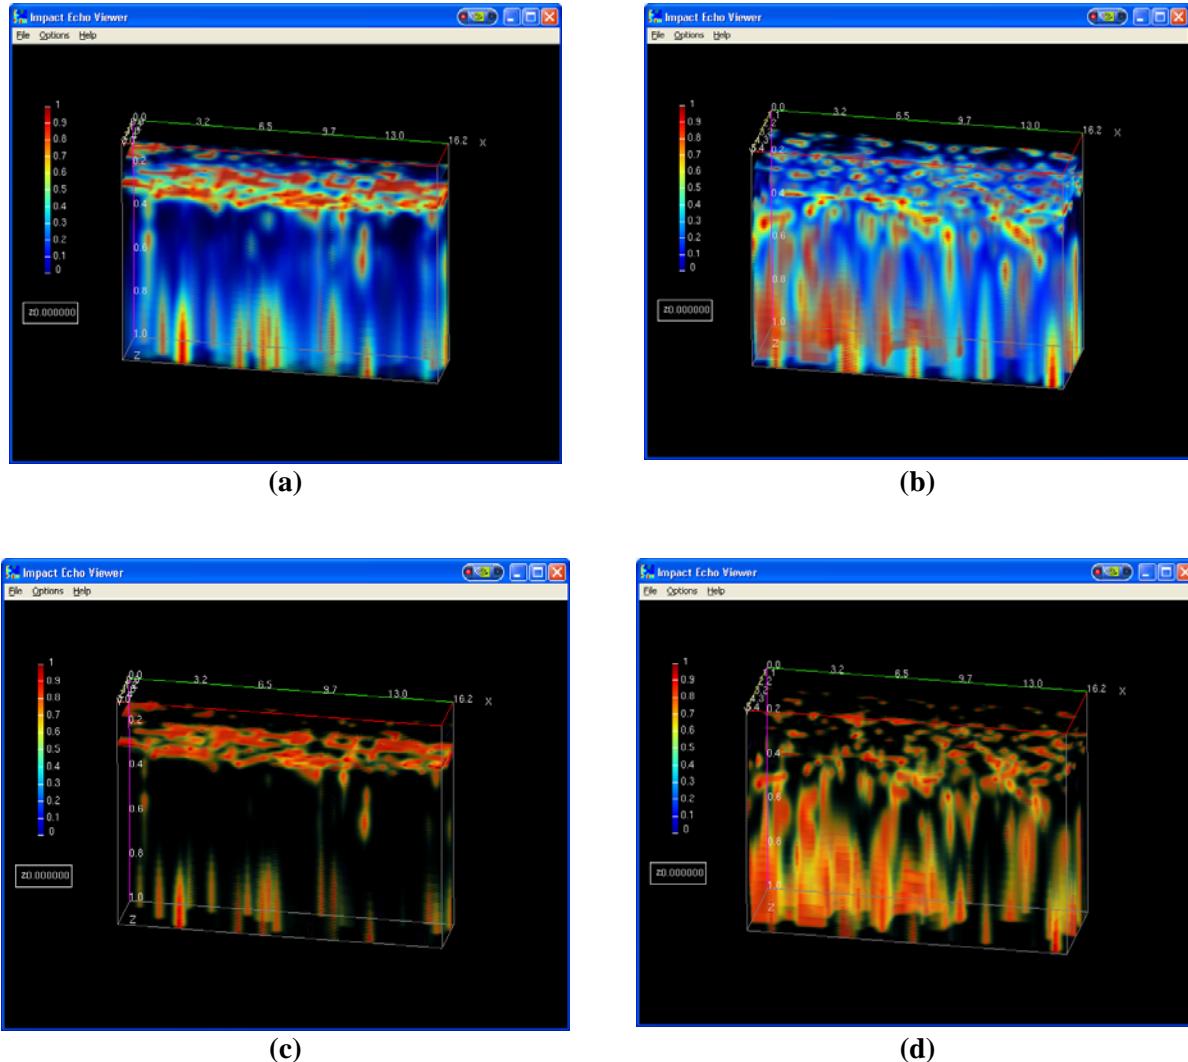
FIGURE 6 Interactive visualization of IE data. Carter Creek Bridge (a) (c), Van Buren Bridge (b) and (d).

A 3D visualization platform for IE data was developed. The platform is written in C++ for Microsoft Windows, and depicted in Figures 6a and 6b for Carter Creek and Van Buren bridge decks. The IE data consists of a reflection value, normalized in the range $[0, 1]$, and sampled on a discrete 3D grid of voxels. Using OpenGL, the data is rendered as a series of texture-mapped planes that slice through the volume, where the reflection strength is used as an index into a colormap look-up table that consists of red, green, blue, and alpha (transparency) values. The user can rotate and shift the camera position, enlarge or shrink the volume and observe the data from different viewing positions and angles. Additionally, as shown in Figures 6c and 6d, the user can interactively adjust the transparency so that weaker reflectors become more transparent, allowing better visualization of the strong reflectors. Similar to the observations in the previous section, in the visualizations provided in Figure 6 it can be noticed that the Carter Creek Bridge, visualized in 6a and 6c is in reasonably good condition. The primary reflections are coming from the bottom of the deck. In contrast, the Van Buren Bridge, visualized in Figures 6b and 6d, has a large number of reflections throughout the volume, indicating a highly deteriorated condition. Data presented in 3D viewer can be inspected as vertical and horizontal cross sections or slices, as illustrated in Figure 7.

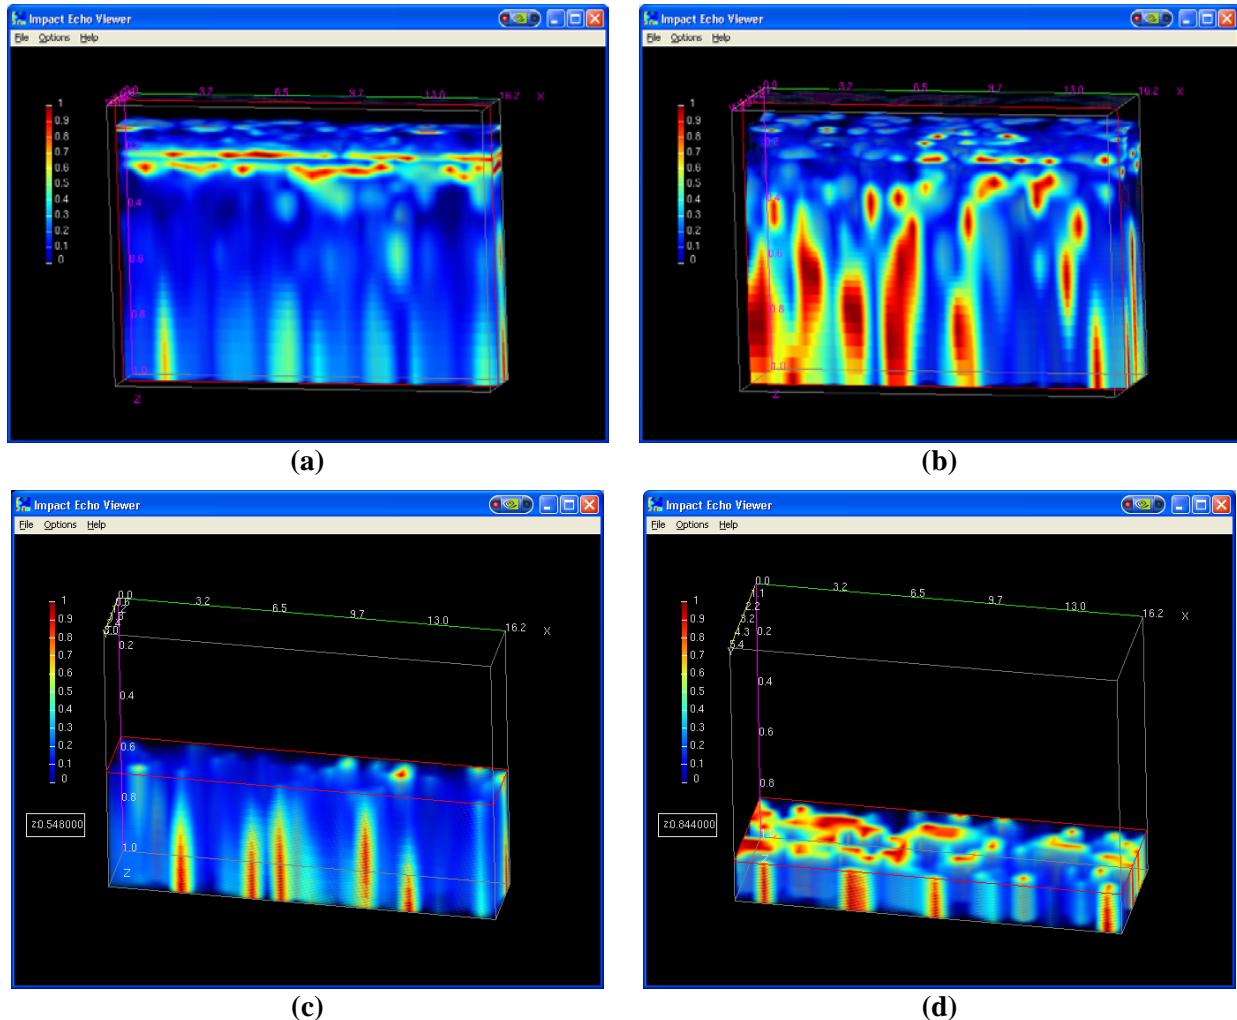
FIGURE 7 Vertical (top row) and horizontal (bottom row) cross-sections through the data. Left: Carter Creek Bridge (vertical section for $y=1.6$ m (a) and horizontal for $z=0.54$ m (c)), Right: Van Buren Bridge (vertical section for $y=3.5$ m (b) and horizontal for $z=0.84$ m (d)).

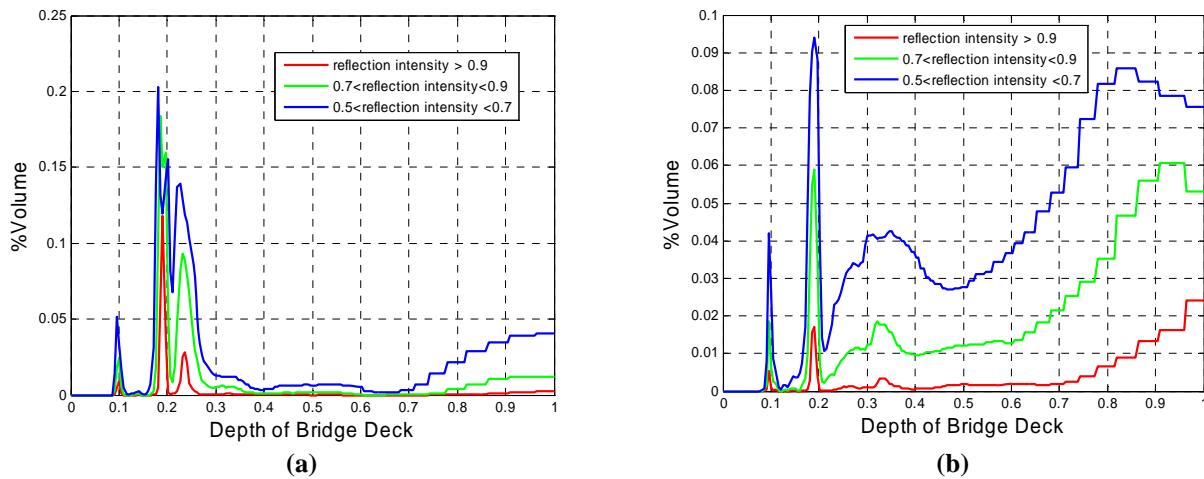
To locate the depth of the strongest reflectors, which could be indicators of defects in a bridge deck, it is very useful to study the relationship between the reflection intensity and depth of the bridge deck. In Figure 8a, strongest reflections appear around a depth equal to about 0.2 m, which corresponds to the bottom of the deck. This phenomenon indicates that the deck is in good condition, consistent with the previous observation and analysis. However, in Figure 8b, strong reflections appear throughout the deck, particularly in the lower regions (close to a 1 m depth) of the deck, indicating presence of flexural oscillations of the upper portion of the deck and thus serious condition.

FIGURE 8 Percent Volume for Various Reflection Intensities vs. Depth. Carter Creek (a), Van Buren (b).

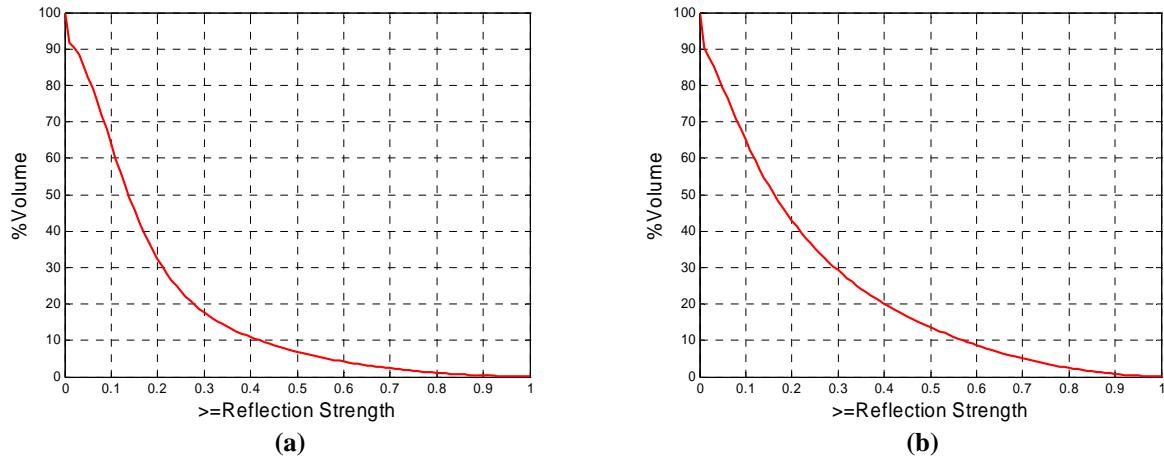
We also examined the cumulative distribution of reflection intensities, shown as Fig. 9. Specifically, these graphs plot the percentage of the IE reflectivity that is greater than or equal to a specific reflection strength. From this figure, it is obvious that strong reflectors at depths deeper than the bottom of the deck are existing in the Van Buren (b) are more than those in the Carter Creek Bridge (a). This is considered to be a sign that the former bridge deck is in a worse condition. Quantitatively, this can be presented in terms of the areas under the curve, which for Carter Creek is 1909.8 and Van Buren Bridge 2376.6.

FIGURE 9 Cumulative Distribution of Reflection Intensity. Carter Creek Bridge (a) and Van Buren Bridge (b).

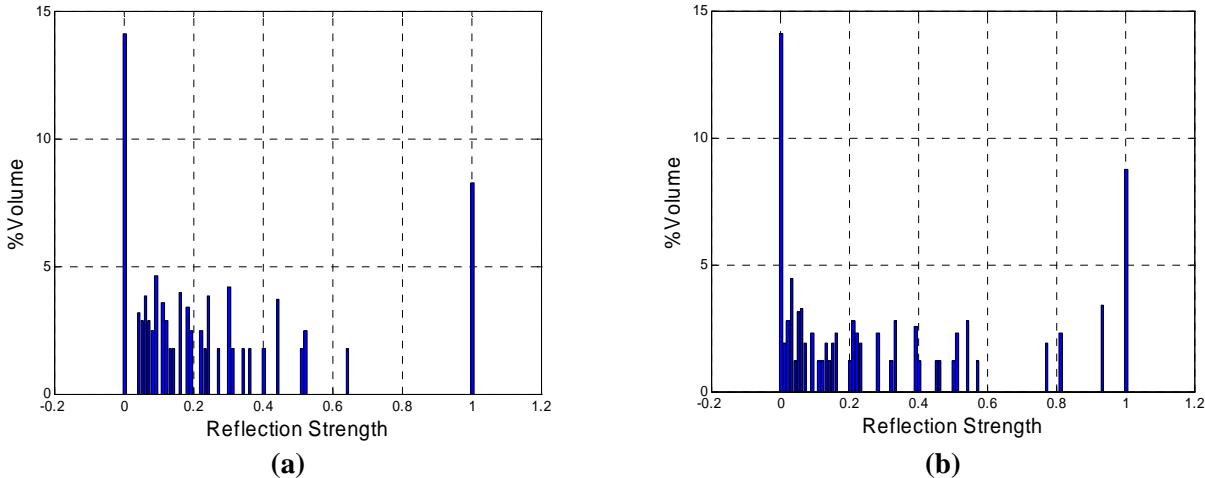
A histogram is the graphical version of a table which shows what proportion of cases fall into each of several or many specified categories. In Fig. 10, the histograms of both bridges are shown. It is worthy noting that the percentage of volume of strong reflection intensity in Carter Creek Bridge is less than Van Buren Bridge, which supports the previous analysis that the latter one is more deteriorated.

FIGURE 10 Histogram of Reflection Intensity. Carter Creek Bridge (a), Van Buren Bridge (b).
 $\text{Log}(\% \text{volume}(\text{at each reflection strength})) + \text{constant}$.

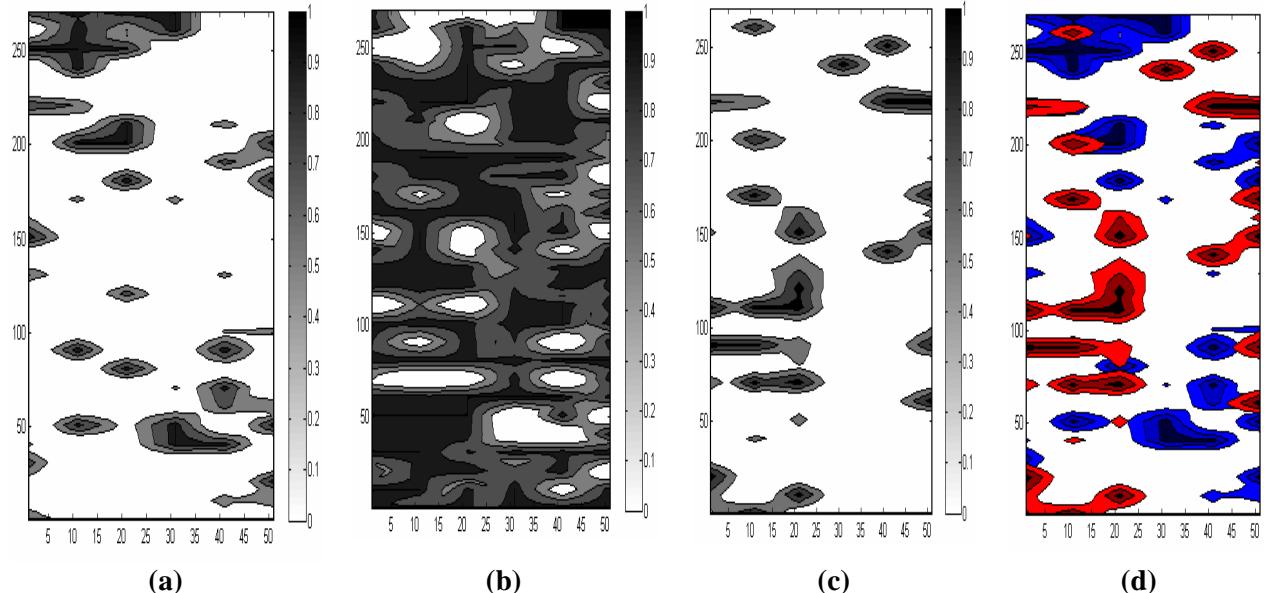
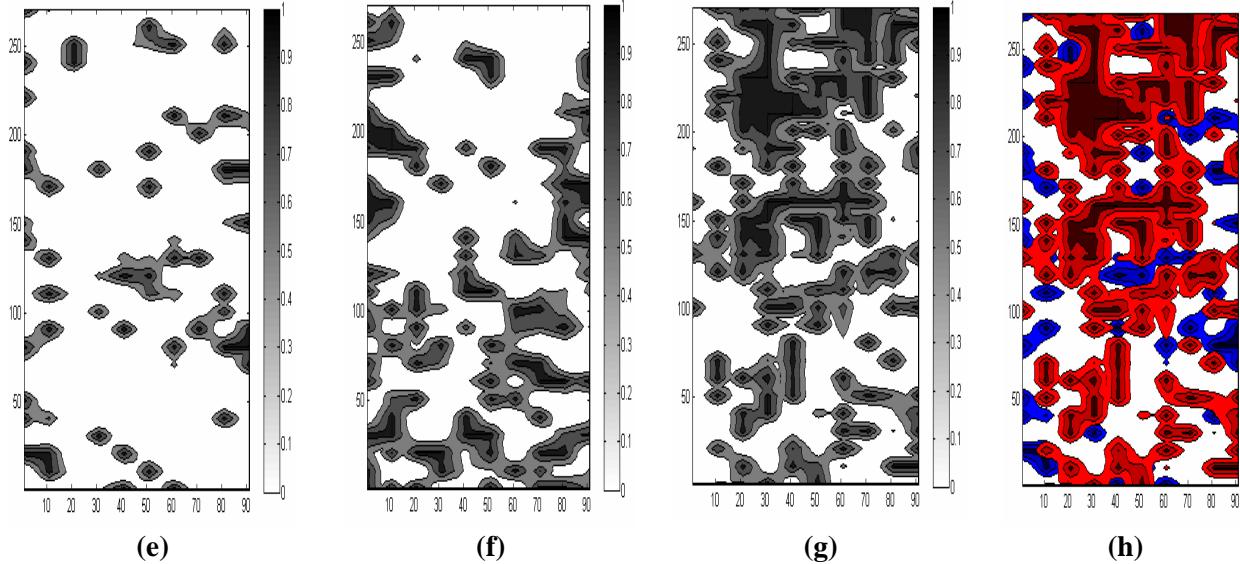
From the practical point, of highest interest and benefit is identification of zones on the deck that are in serious condition (progressed delamination) or fair to poor condition (initial delamination). The process of identification of such zones is illustrated in Figure 11. Initial delamination (fair to poor conditions) is primarily identified by medium to strong reflections at the depth corresponding to the position of the top rebars. This is illustrated in Figures 11a and 11e for Carter Creek and Van Buren bridges, respectively,

with strong reflection maps for slices between 7 and 13 cm. Similarly, sound zones of the deck are identified by strong reflections from the bottom of the deck, or in this case described by slices between 16 and 24 cm depth in Figures 11b and 11f. (Clearly, the Carter Creek Bridge deck is in a better condition.) Finally, progressed delamination (serious condition) can be described by strong reflection maps for the slice for the depth deeper than the depth of the bottom of the deck. This is illustrated by the strong reflection maps for slices between 30 cm and 1 m in Figures 11c and 11g. To obtain the map of zones candidates for repair, the map for serious condition is superimposed on the map of initial delamination, as e.g. repair map in Figure 11d is obtained from the map in Figures 11c superimposed on the map in Figure 11a. A comparison of maps for Carter Creek Bridge in Figure 11d and Van Buren Bridge in Figure 11h points clearly to significantly higher deterioration and need for repair of the latter one.

FIGURE 11 Plan view contour plots for deck repair. Top: Carter Creek Bridge, Bottom: Van Buren Bridge. Left to right: the maximum reflectance in the “delamination zone” slice (0.07m~0.13m) (a)(e), in the “bottom of the deck” slice (0.16m~0.24m)(b)(f), and in the “apparent deep reflector” zone (0.3m~1m)(c)(g). Identified deteriorated zones (d) and (h) (red - serious condition, blue – fair to poor condition).
